JCAA/JGPP Lead-Free Solder Testing for High Performance Applications

Thermal Cycle Testing: -55°C to +125°C

Dave Hillman Rockwell Collins

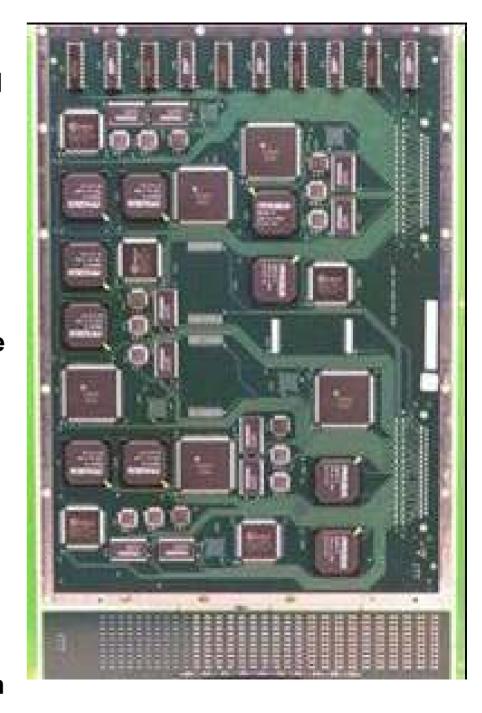
Test Vehicle & Solder Alloys:

- •Sn3.9Ag0.6Cu (SAC) for reflow and wave soldering
- •Sn3.4Ag1.0Cu3.3Bi (SACB) for reflow soldering
- •Sn0.7Cu0.05Ni (SNIC) for wave soldering
- •Sn37Pb (SnPb) for reflow and wave soldering
- Manufactured PWBs
- •FR4 per IPC-4101/26 with a minimum Tg of 170°C with an immersion silver surface finish.
- Reworked "Legacy" PWBs
- •FR4 per IPC-4101/21 with a minimum Tg of 140°C with a hot air, solder leveled (HASL) surface finish

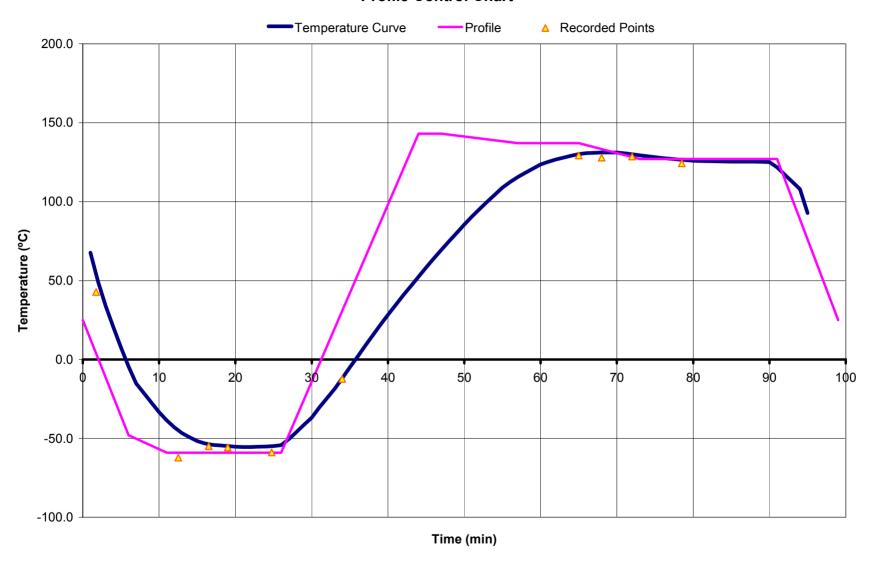
Profile Control Chart

Thermal Cycle Testing Methodology:

- In accordance with IPC-9701
- Temperature Extremes: -55°C and +125°C
- Temperature Ramp: 5°C-10°C per minute maximum
- Temperature Dwells: 10 minutes @ -55°C

30 minutes @ +125°C

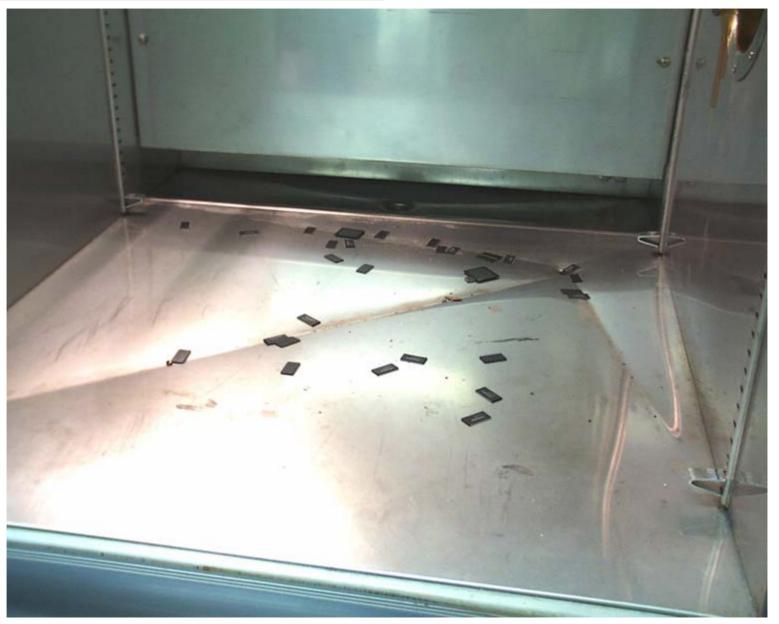
- 4743 Total Thermal Cycles Completed
 - 12 months of Testing !!!

Component Type	Total Failures	Total Population	Percent Failured
BGA 225	257	300	85.7
CLCC 20	300	300	100
PDIP 20	24	300	8
PLCC 20	8	150	5.3
TQFP 144	136	150	90.7
TQFP 208	110	150	73.3
TSOP 50	296	300	98.7

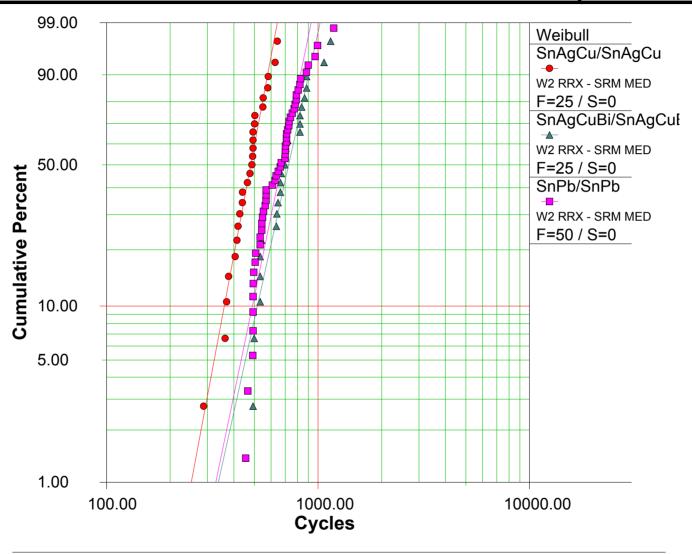
CLCC test results - Manufactured test vehicles (170°C Tg)

β 1=6.5409, η 1=508.6653, ρ =0.9864 β 2=5.5317, η 2=776.3182, ρ =0.9453 β 3=5.9047, η 3=716.4935, ρ =0.9326

β2=5.5317, η2=776.3182, ρ=0.9453 Key: Solder Alloy/Component Finish

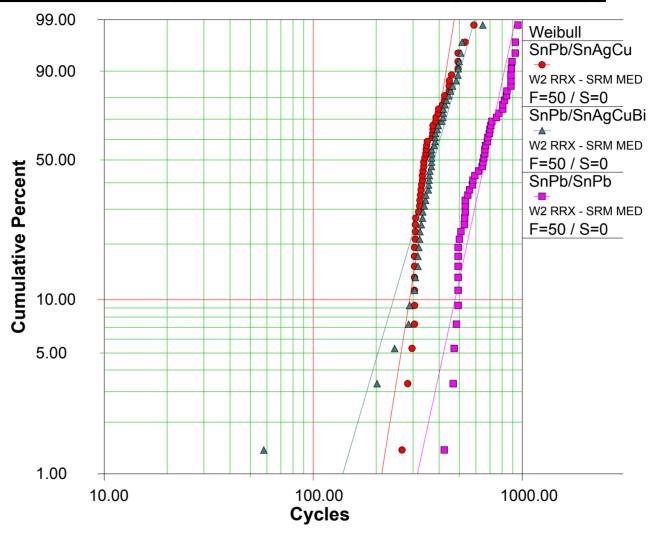
CLCC test results: Legacy test vehicles (140°C Tg)

$\beta 1=7.6691$, $\eta 1=387.3908$, $\rho=0.8914$ $\beta 3=5.6773$, $\eta 3=708.6388$, $\rho=0.9368$

β2=4.2149, η2=412.5278, ρ=0.8758 Key: Solder Alloy/Component Finish

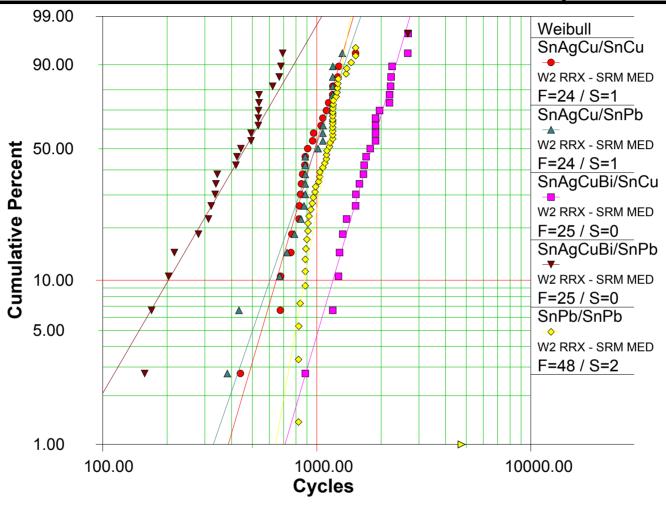
TSOP test results: Manufactured test vehicles (170°C Tg)

β 1=4.5501, η 1=1061.7576, ρ =0.9732 β 2=3.8599, η 2=1082.2162, ρ =0.9642

β_3 =4.5553, η_3 =1950.6106, ρ =0.9890 Key: Solder Alloy/Component Finish

β 4=2.2892, η 4=542.1344, ρ =0.9096 β 5=7.5694, η 5=1179.9001, ρ =0.9443

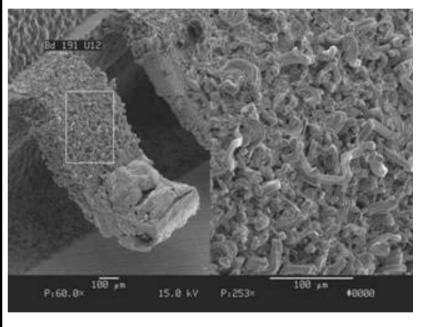
SEM image of TSOP component with SnCu surface finish –

Originally soldered with SnPb (140°C Tg PWB) then manually reworked with SAC

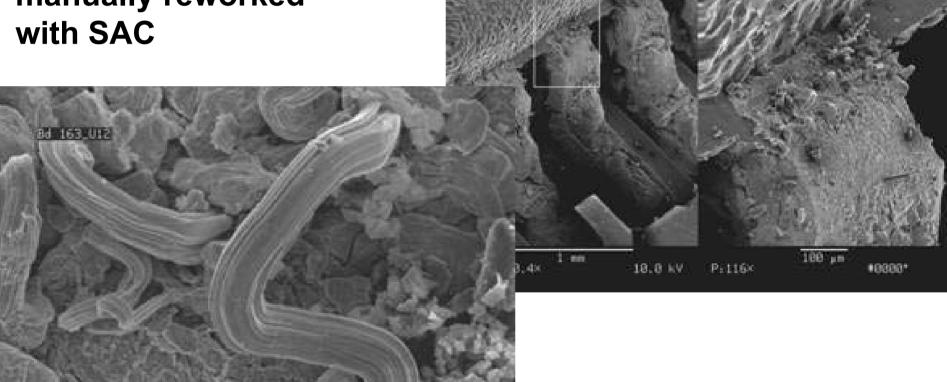
SEM image of TQFP component with Sn surface finish –

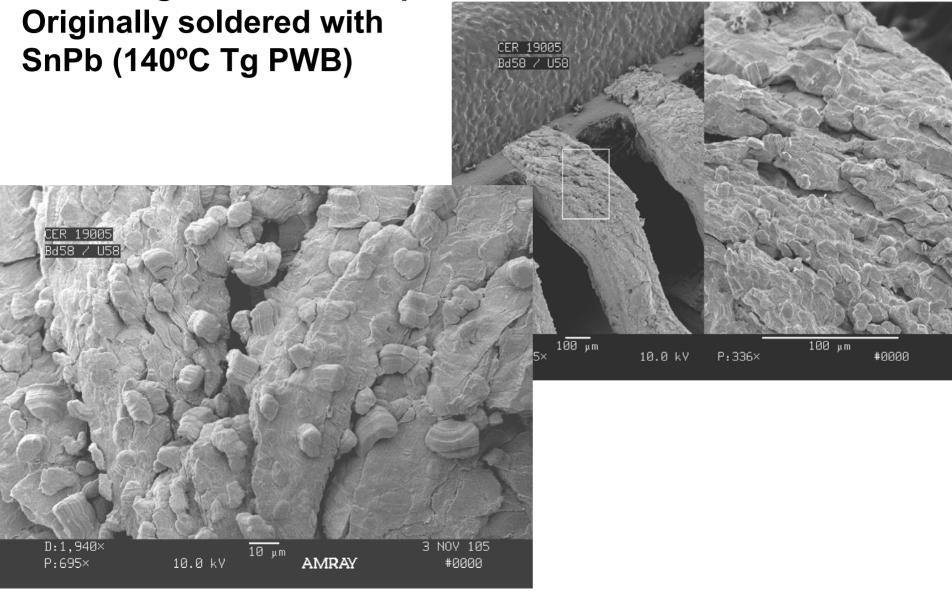
SEM image of TQFP component with Sn surface finish – Originally soldered with SnPb (140°C Tg PWB)
